Illinois Commerce Commission  
Assessment of Mt. Carmel Public Utility Company's  
Reliability Report and Reliability Performance  
for Calendar Year 2004

Pursuant to 83 Ill. Adm. Code 411.140

# 2004 Reliability Assessment: Mt. Carmel Public Utility Co.

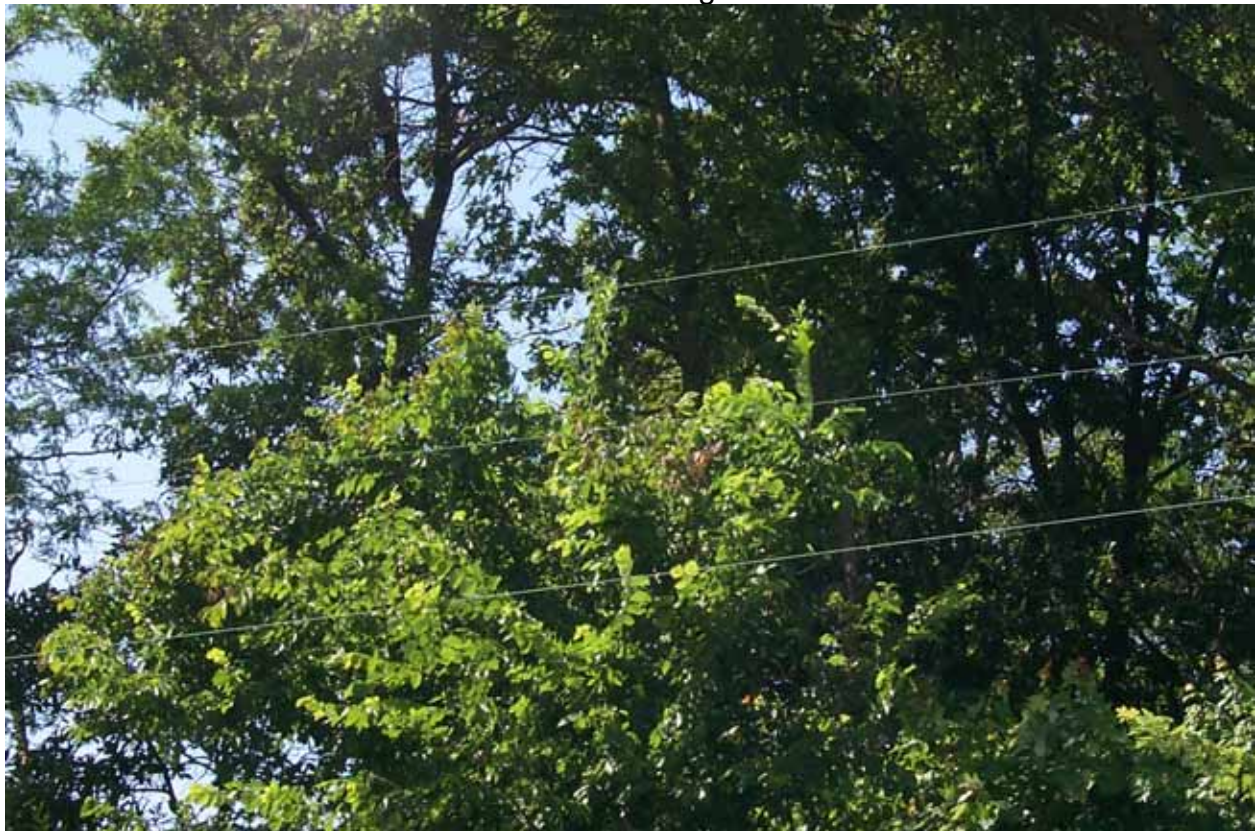
Staff found eighteen locations where the circuit's reliability could be compromised. See Attachment A for a complete description of the eighteen locations. Fourteen of these locations Staff found trees or vines growing near or into the primary conductor(s). Considering this circuit was reported to have completed its three year cycle tree trimming in March 2005 Staff did not expect to find this many tree related problems during the inspection of the circuit. Staff recommends Mt. Carmel executes a more comprehensive tree trimming as part of their three year tree trimming cycle.

The remaining four locations were where poles and/or hardware were found to be in bad or deteriorated condition. Photo #1 is an example of some of the tree conditions and photo #2 is an example of some of the bad or deteriorated conditions found on this circuit during Staff's inspection and trees during Staff's inspection.

On Beall Woods Avenue East of Mt. Carmel  
Conductors touching the tree

Given the length of this circuit (41 miles) Staff was pleased with the overall condition of distribution facilities but Staff is concerned with the number of locations that trees and vines were found growing near or into the conductor considering that the tree trimming of this circuit was completed three months prior to Staff's inspection of this circuit. Mt. Carmel should verify that the tree trimming is sufficient to maintain proper clearance to implement its three year cycle.

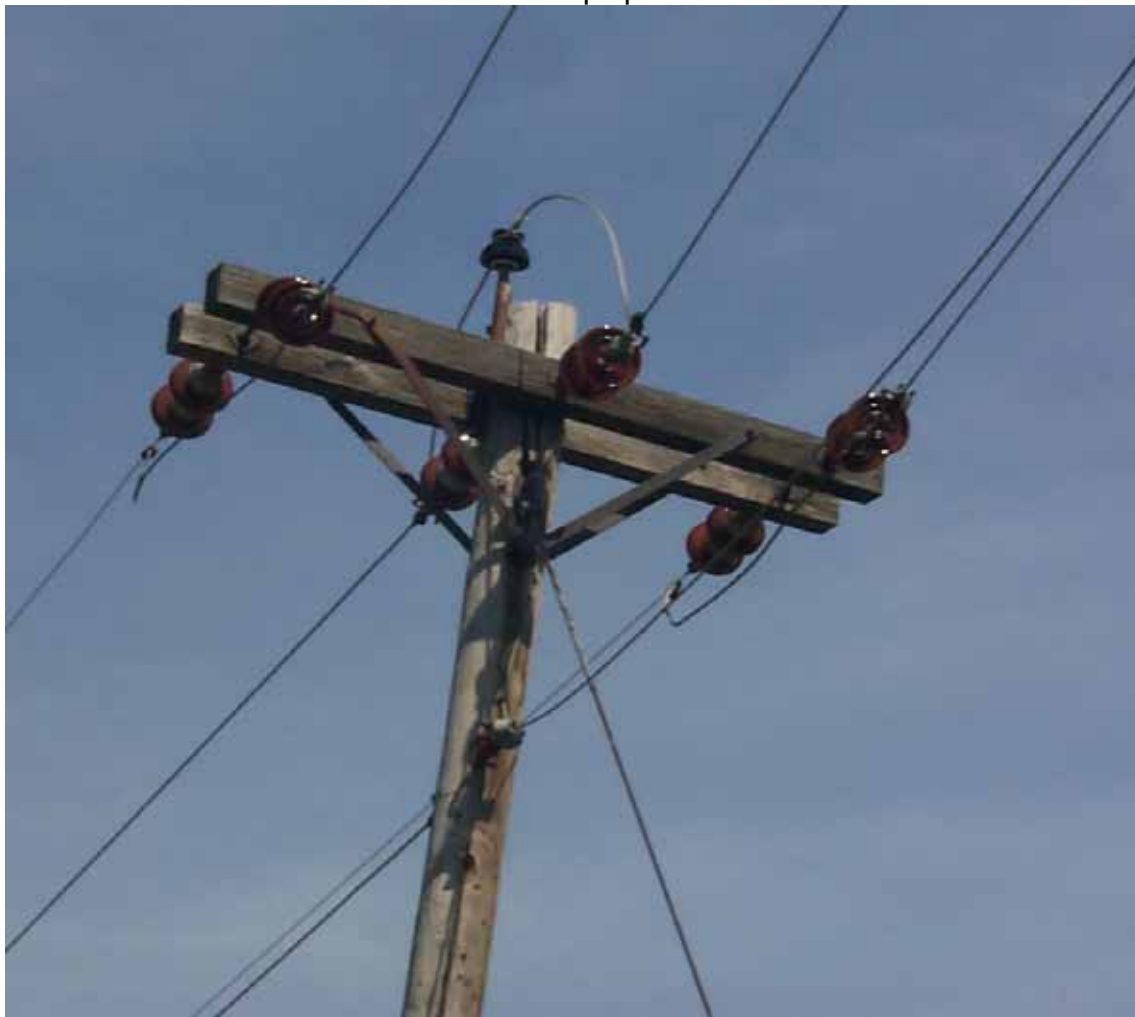
Photo #2  
On E700 Rd East of Mt. Carmel  
Pole top split
